# Hazardous Building Materials Inspection

1 King Place

Meriden, CT

**Re: Hazardous Building Materials Inspection  
Former Veteran's Memorial Hospital  
1 King Place, Meriden, CT**  
Fuss & O'Neill EnviroScience Project No. 20120232.C4E

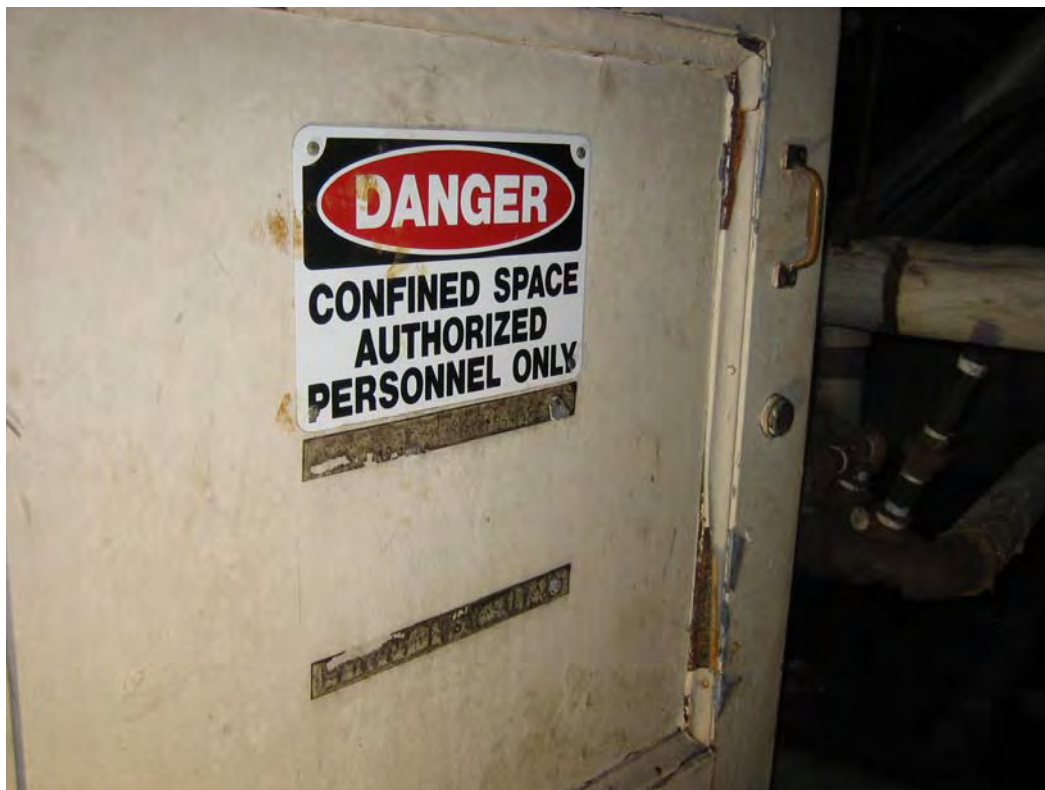
1952 Building – 1<sup>st</sup>/2<sup>nd</sup> floor Stairwell B confined space access

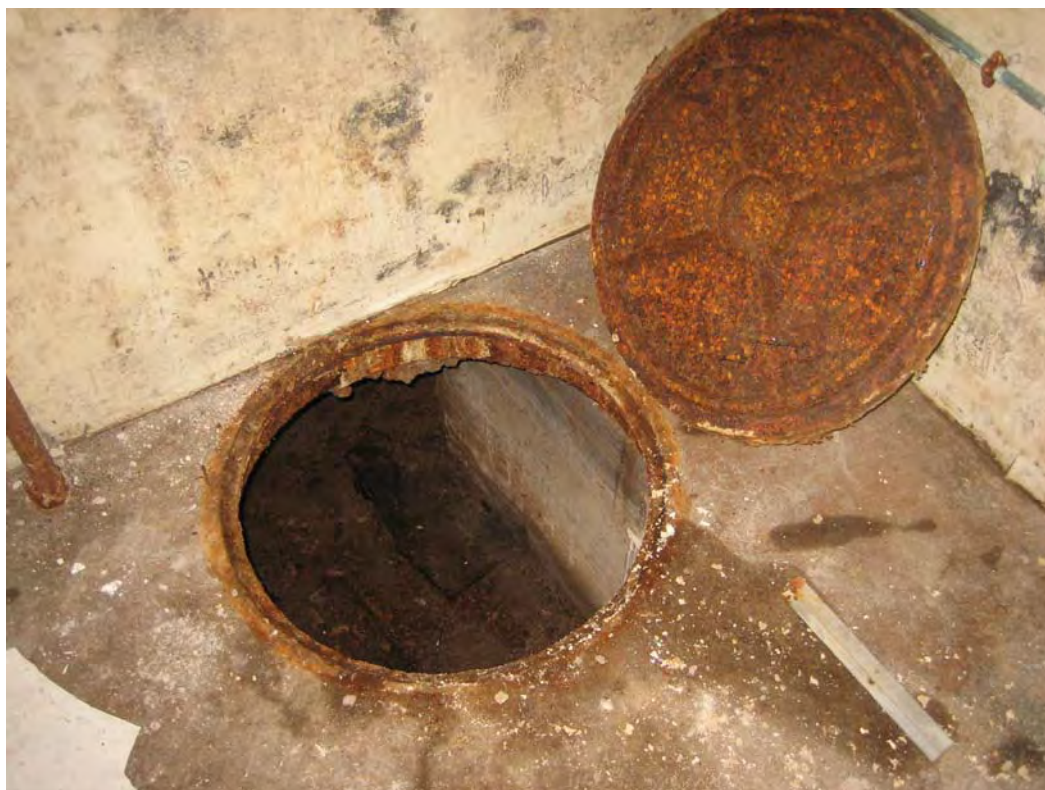
1952 Building – 2<sup>nd</sup> floor Kitchen prep area confined space access

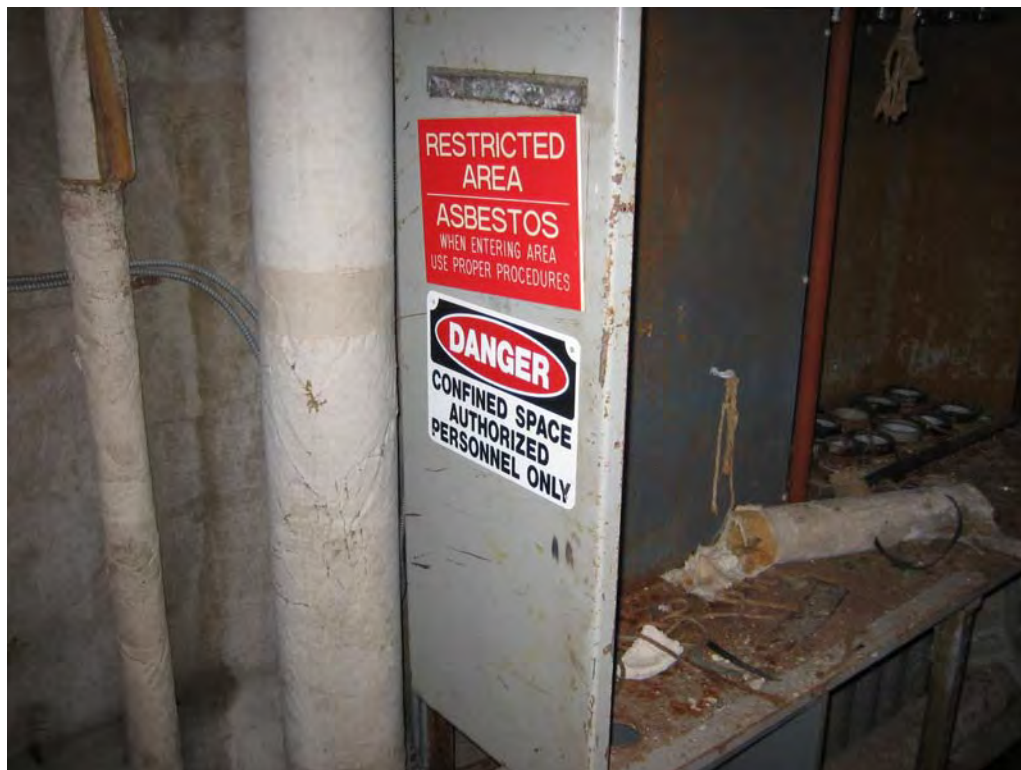
1958 Building – 1<sup>st</sup> floor Room 100A Confined space access

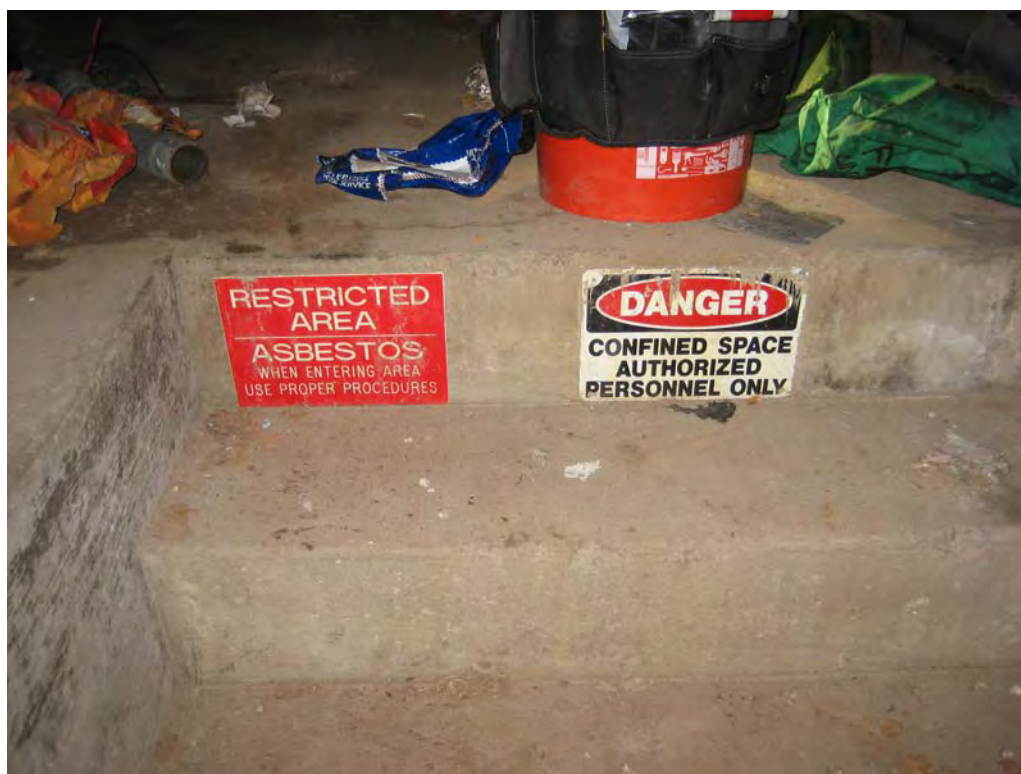
North Addition – 1<sup>st</sup> floor Confined space access (accessed from 1952 1<sup>st</sup> floor).

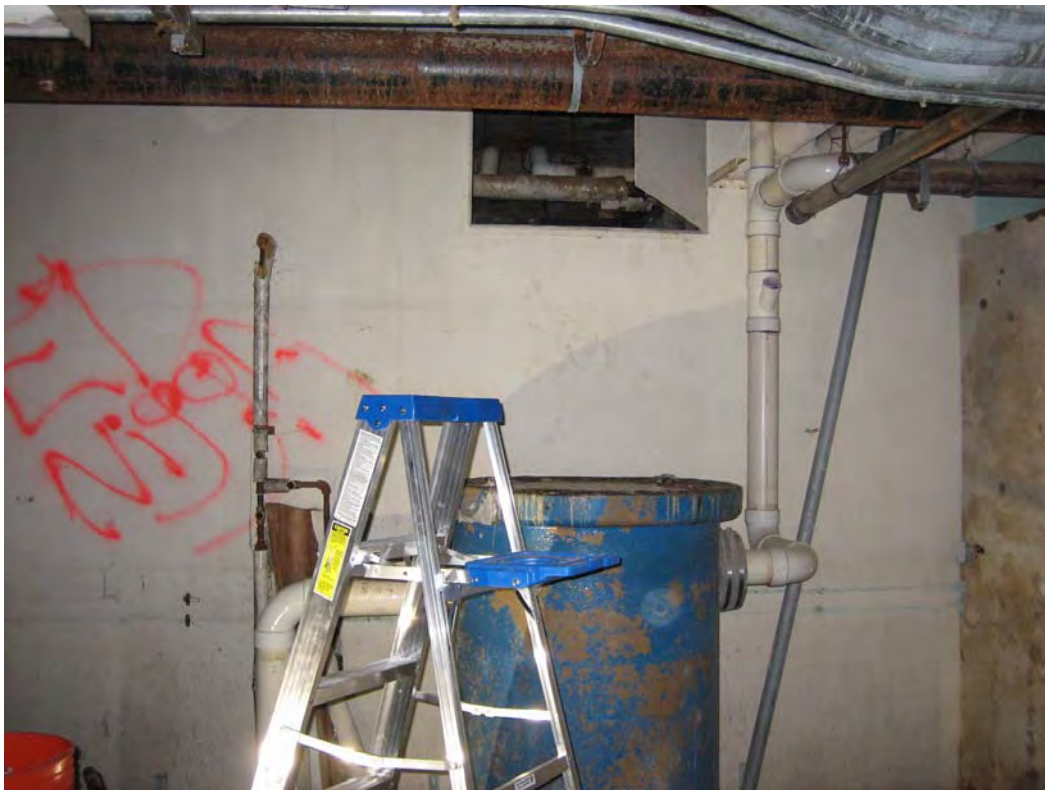
1968 Building – Basement overhead pipe chase

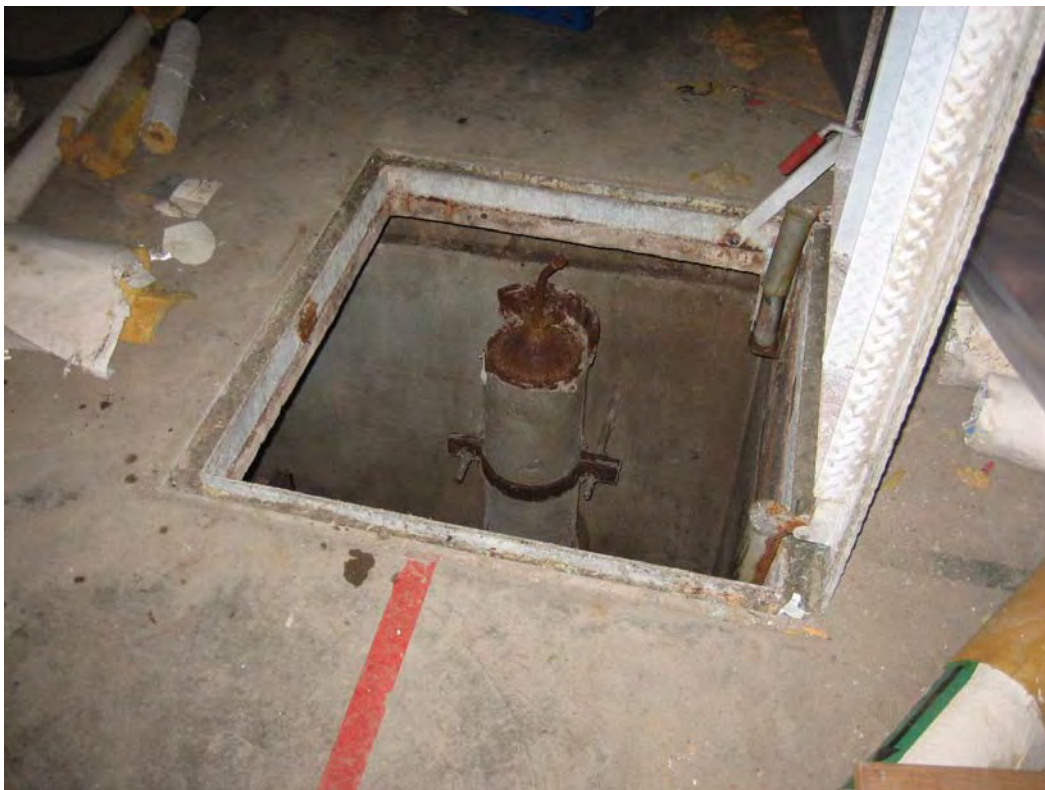
Laundry – 1<sup>st</sup> floor sump area confined space access
