Re: **Hazardous Building Materials Inspection Report,
Mold Evaluation and Radon Air Sampling
Record Journal Building
11 Crown Street Meriden, CT**

RECORD JOURNAL
11 CROWN STREET, MERIDEN, CT

**HAZARDOUS BUILDING
MATERIALS INSPECTION**
BASEMENT AND FIRST FLOOR PLANS

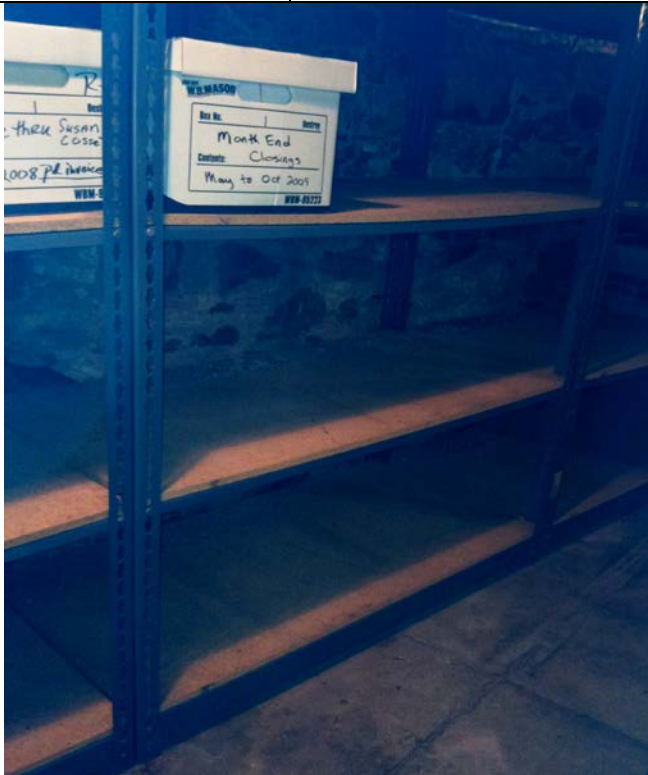
Tighe&Bond		PHOTOGRAPHIC LOG	
Client Name: City of Meriden		Record Journal 11 Crown Street, Meriden, CT	Project No. 220817
Photo No. 1	Date: 4/8/14

Area Photo Taken: Room 006 - Storage			
Description: Delamination of concrete mortar due to moisture.

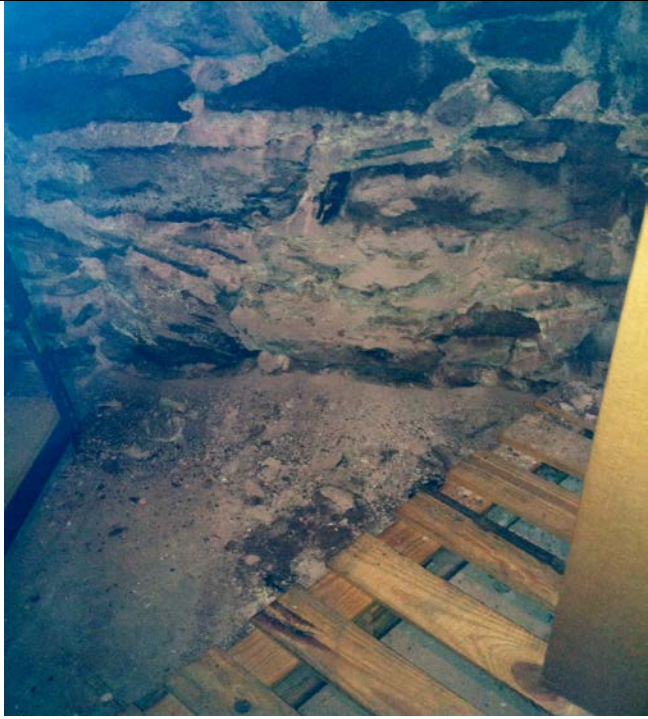
Tighe&Bond		PHOTOGRAPHIC LOG	
Client Name: City of Meriden		Record Journal 11 Crown Street, Meriden, CT	Project No. 220817
Photo No. 2	Date: 4/8/14

Area Photo Taken: Room 006 - Storage			
Description: Delamination of concrete mortar due to moisture.

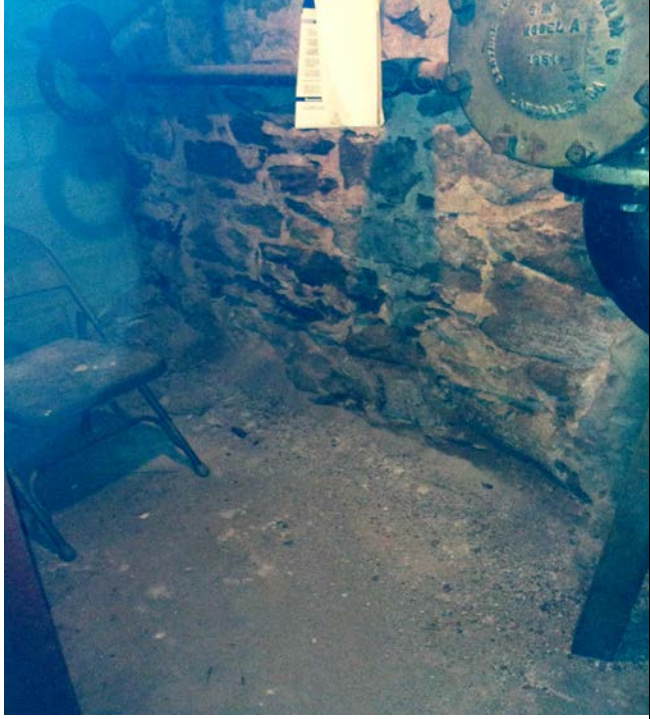
Tighe&Bond		PHOTOGRAPHIC LOG	
Client Name: City of Meriden		Record Journal 11 Crown Street, Meriden, CT	Project No. 220817
Photo No. 3	Date: 4/8/14

Area Photo Taken: Room 006A			
Description: Delamination of concrete mortar due to moisture.

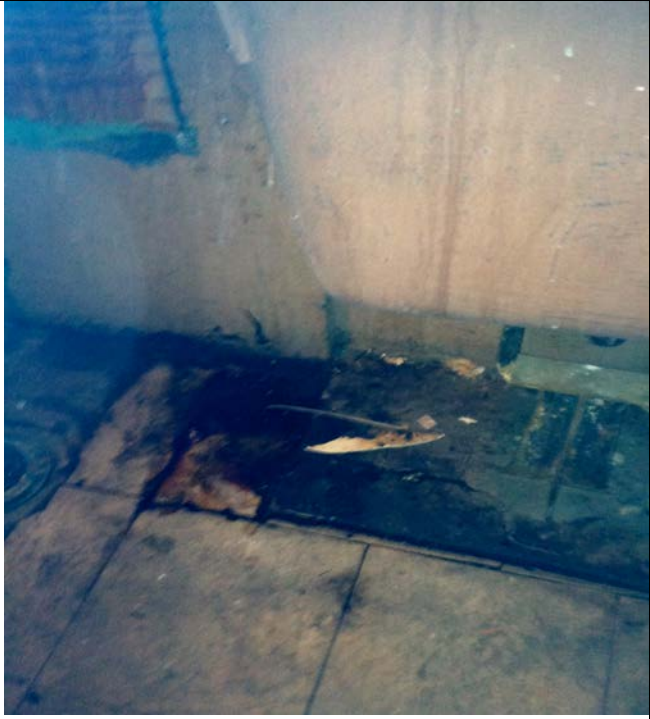
Tighe&Bond		PHOTOGRAPHIC LOG	
Client Name: City of Meriden		Record Journal 11 Crown Street, Meriden, CT	Project No. 220817
Photo No. 3	Date: 4/8/14

Area Photo Taken: Room 005A			
Description: Visible mold due to leaking sink.
